OLD WINE IN NEW BOTTLES: ACTIVE TECTONICS AND ACTIVE LANDSCAPES IN AN ANCIENT OROGEN

Guidebook Editors:

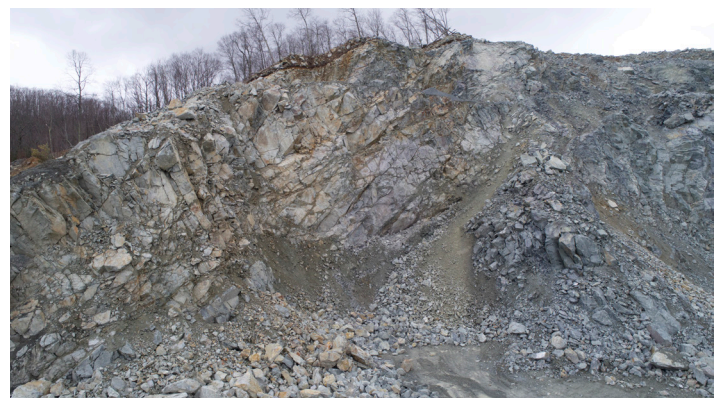
Figure 2. Fractures and faults within the meta-sandstone. We interpret these structures to be associated with Neogene motion on the Boone fault.

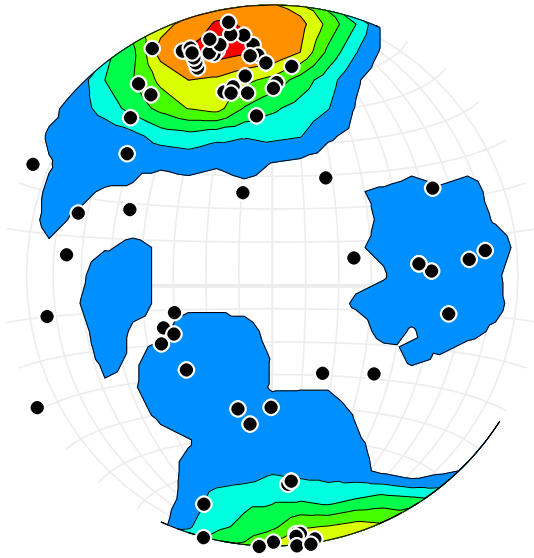
Figure 3. Equal-area plot of poles to fractures and minor faults exposed in a roadcut through the meta-sandstone body along NC-105 near Boone quarry entrance. Measured by Jesse Hill.

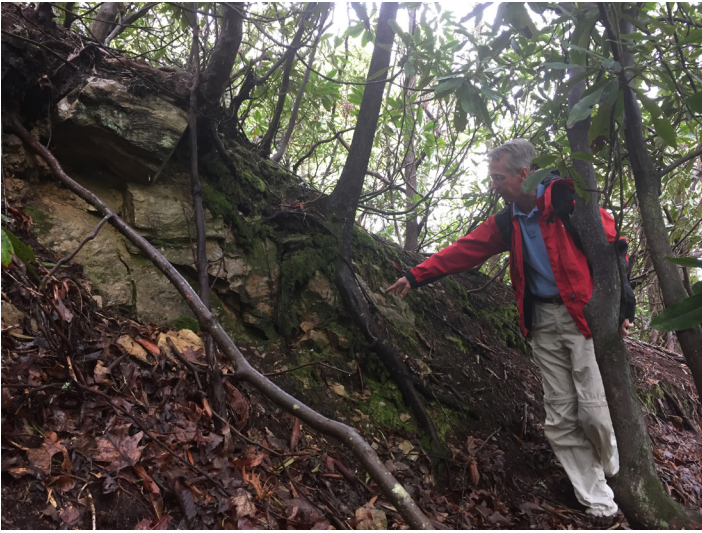
Figure 6. Outcrop of folded, fractured mylonitic chlorite-sericite-quartzo-feldspathic gneiss (Ygg) exposed in the main scarp of the slide. The mylonitic foliation dips out of the slope toward the north. View looking south. 2018_05_17 NCGS photo.

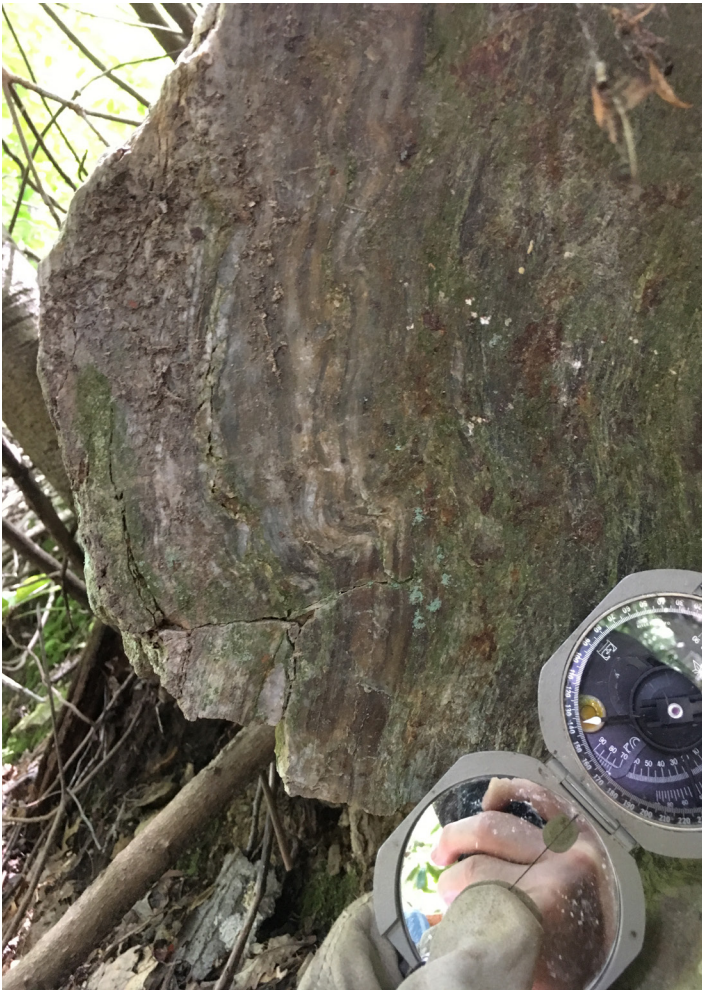
Figure 7. Close-up view of the folded mylonitic foliation exposed on a fracture face in the outcrop in Figure 6. Mylonitic foliation consists of mm-scale, alternating quartzo-feldspathic, and sericite-chlorite layers. 2018_07_05 NCGS photo.

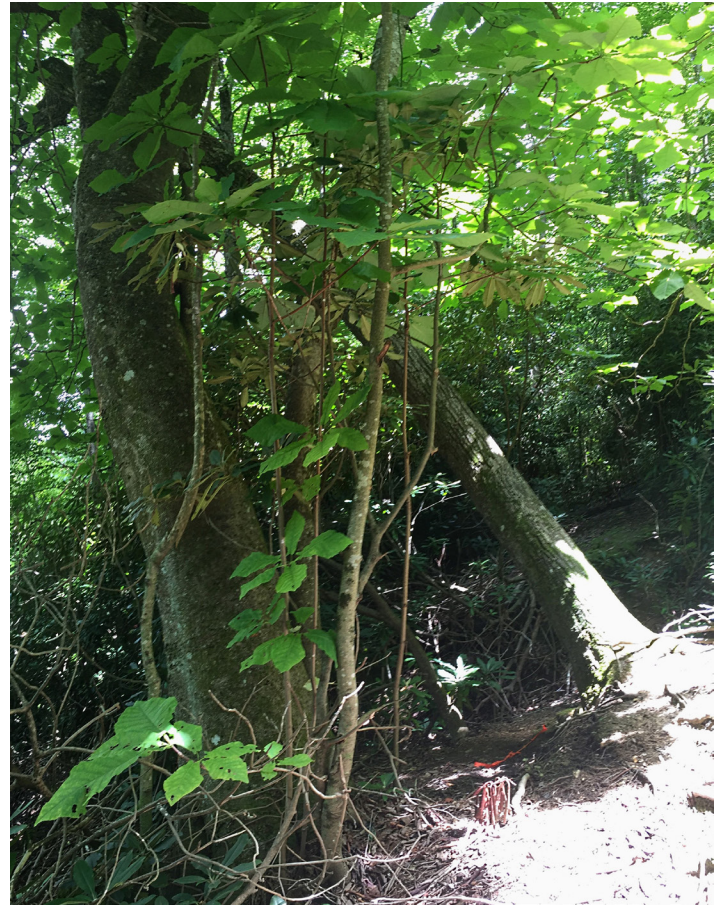
Figure 8. Photograph of curved and leaning trees on the rock slide. Slide movement is downhill toward the left (north). 2018_07_05 NCGS photo.

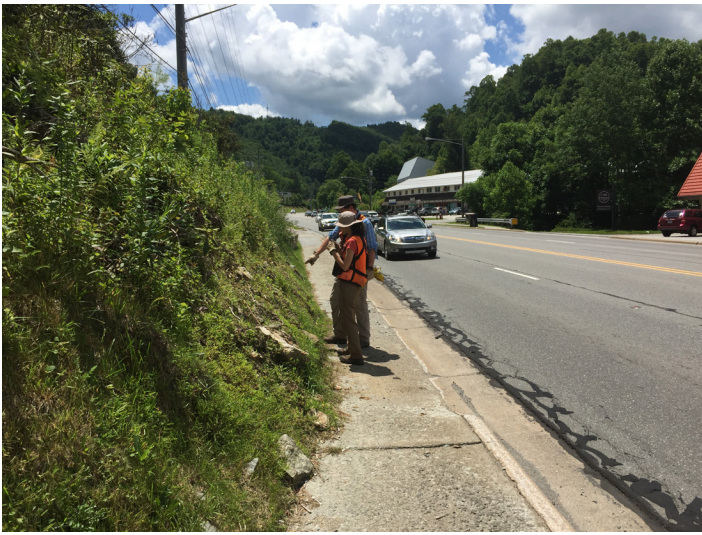
Figure 9. Photograph of the rocky debris at the slide toe impinging on the sidewalk along SR 105. View looking west. 2018_07_05 NCGS photo.

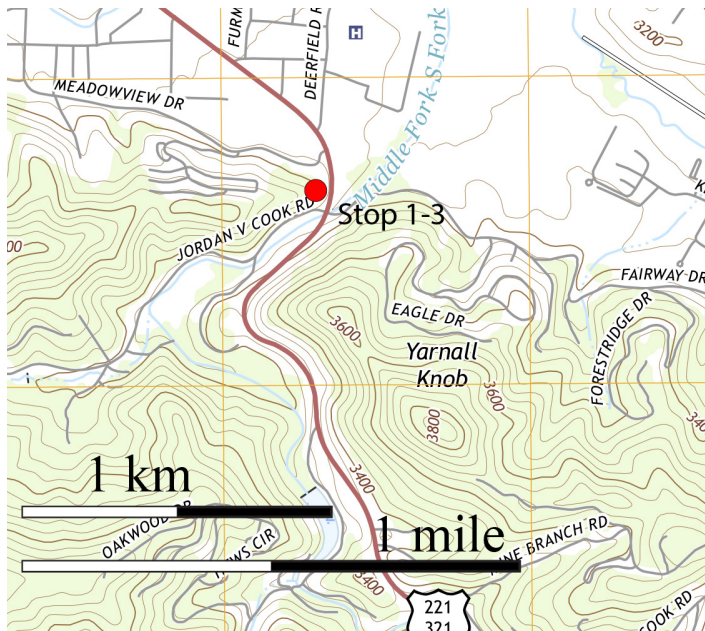
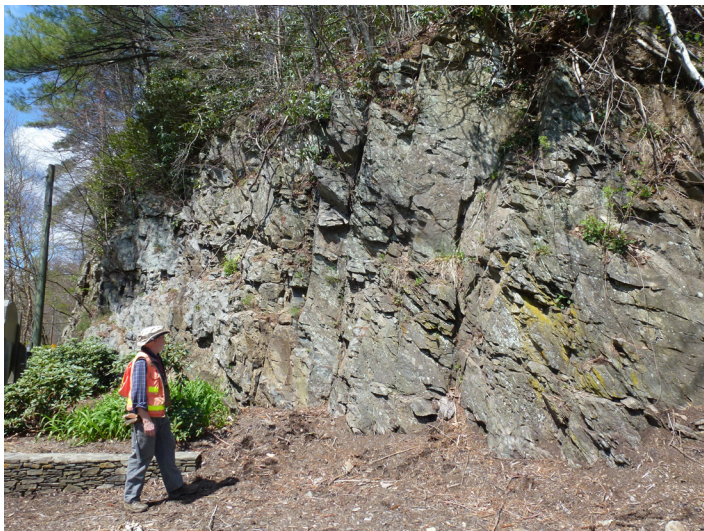
Figure 1. Exposure of foliated Grandfather Mountain formation meta-siltstone cut by steeply dipping brittle faults and fractures associated with motion on the Boone fault.

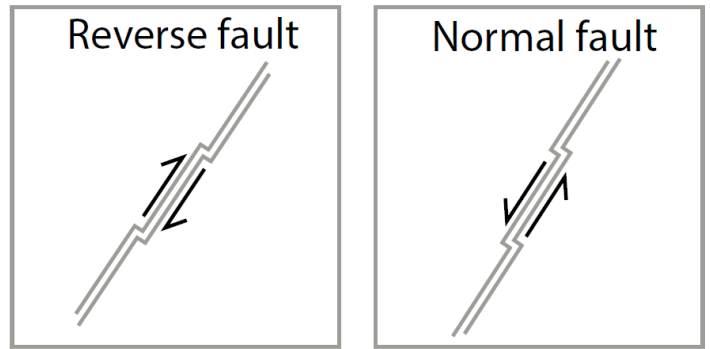
Figure 4: Example slickenline with steps. Fault surface is coming out of image and grey lines indicate steps along the plane.

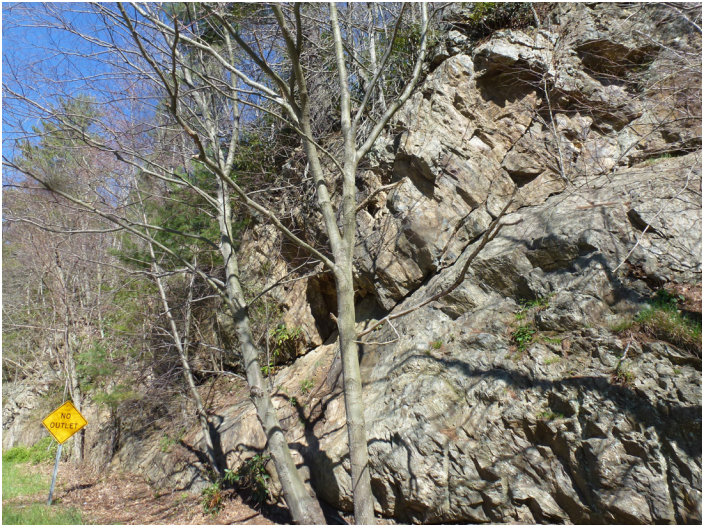
Figure 6: Potential rock-slide detachment surface (visible from bottom-left corner to top-right corner of image) created by intersection of foliation and fractures.

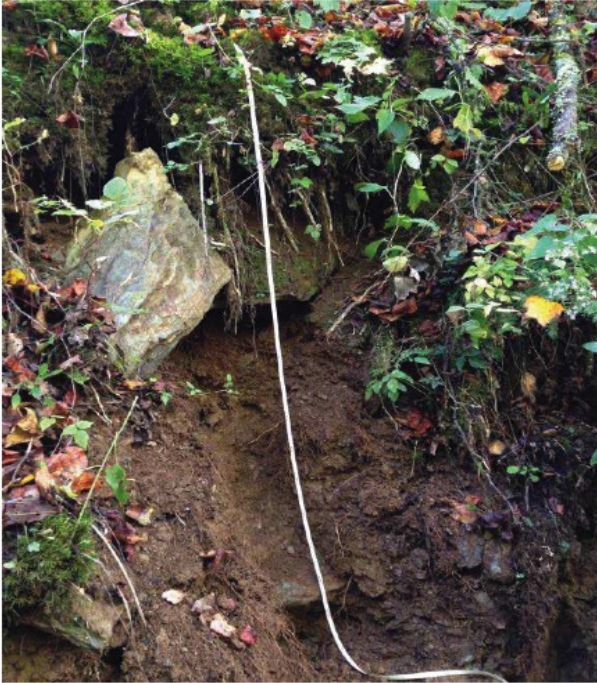
Figure 5. Exposure of diamicton with pebble to boulder size clasts originating from the western valley wall. It was deposited in August 1940 by a debris flow that began as a slide and became a flow as it blocked Flannery Fork (as shown on Figure 21).

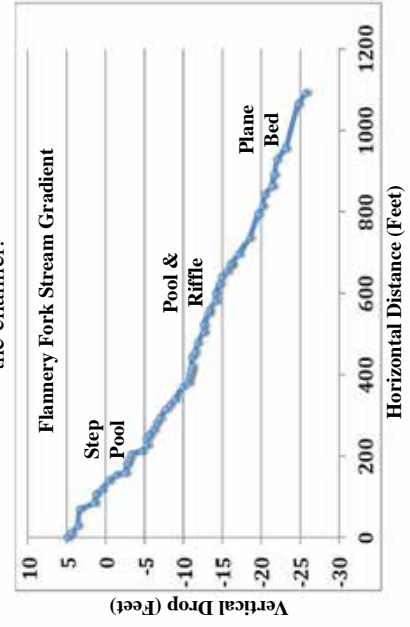
Figure 15. Flannery Fork stream gradient with types of stream channel morphology indicated.

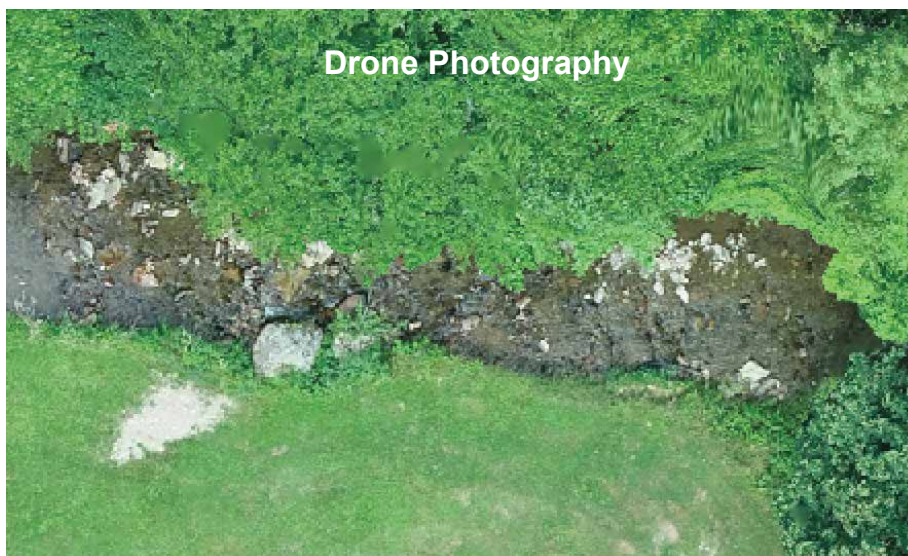
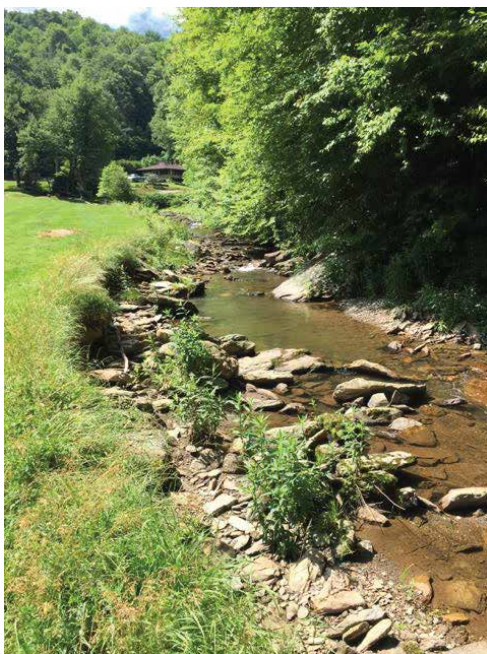
Figure 16. Pool and riffle channel morphology. Aerial view and channel view shown.

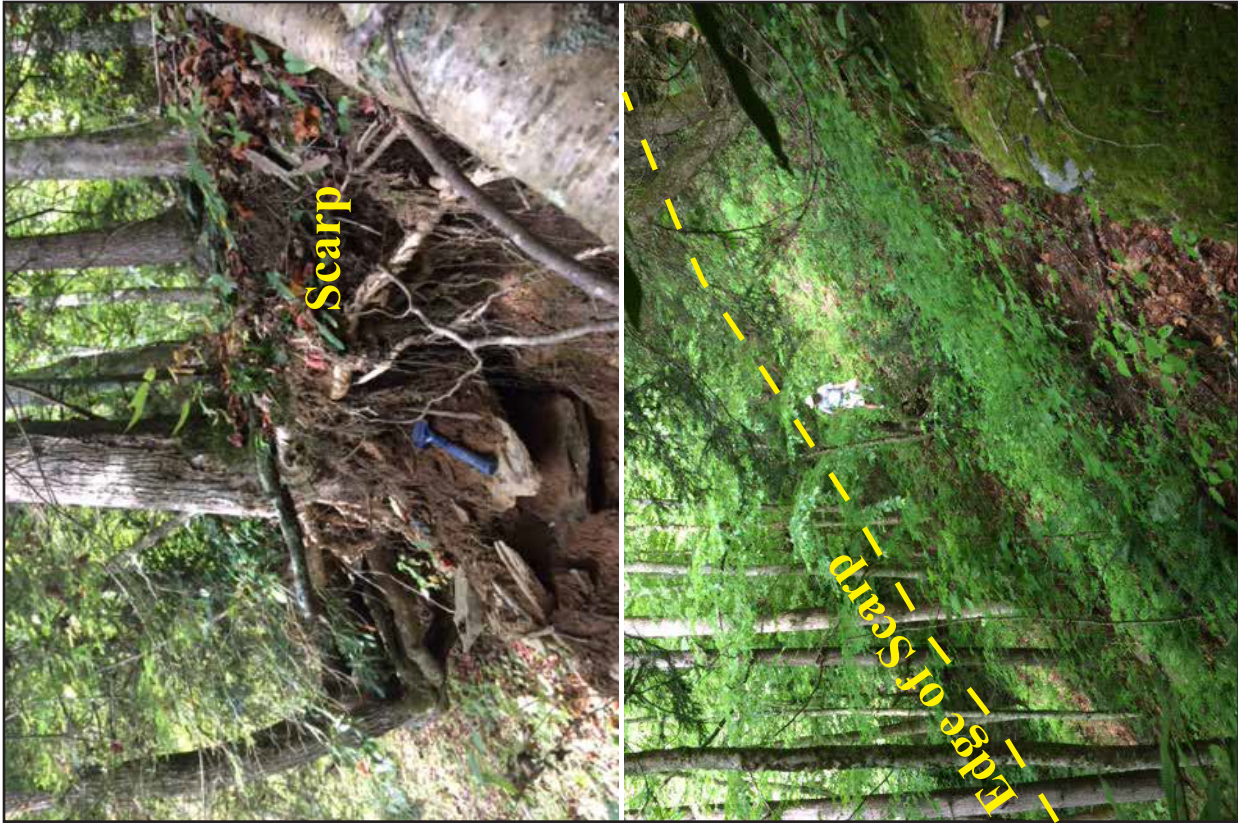
Figure 23. Views of the 1940 debris slide scar. The vertical scarp is present at the top of the scar. Smaller trees occur within the scar and scattered exposures of bedrock can be observed.

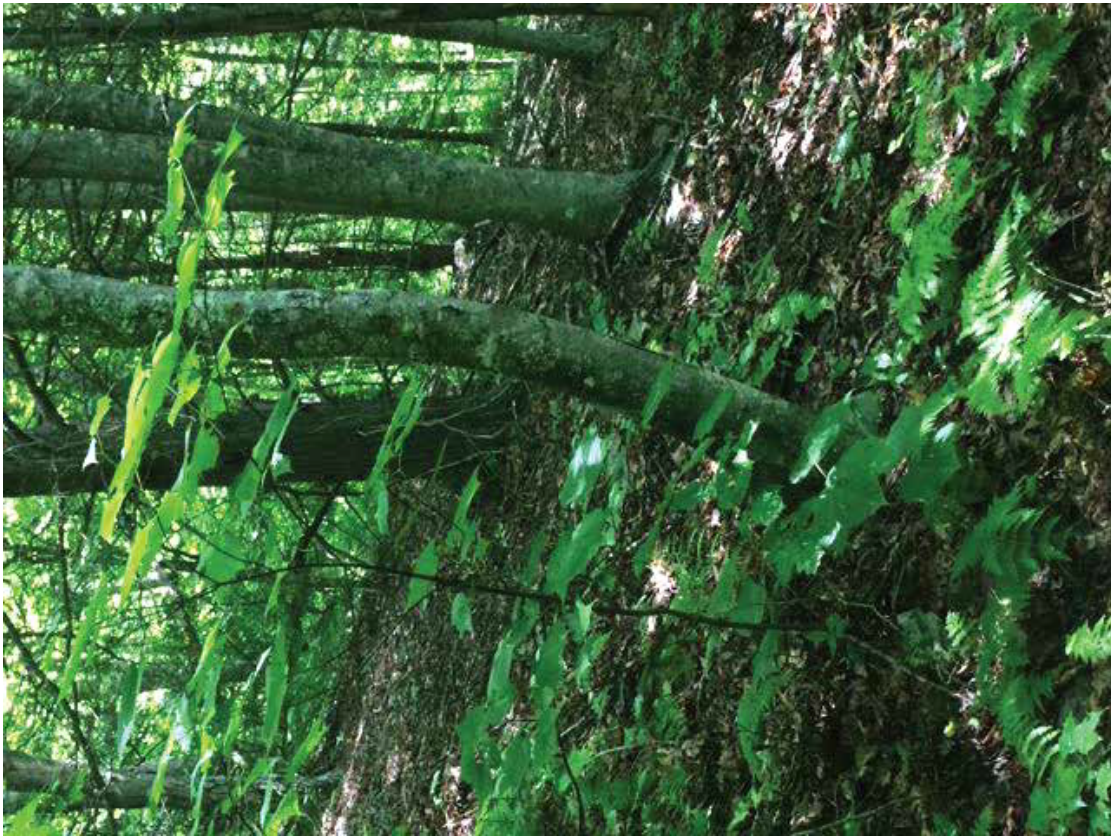
Figure 24. Bent trunks are an indication of continuing soil creep on the steep western slope.

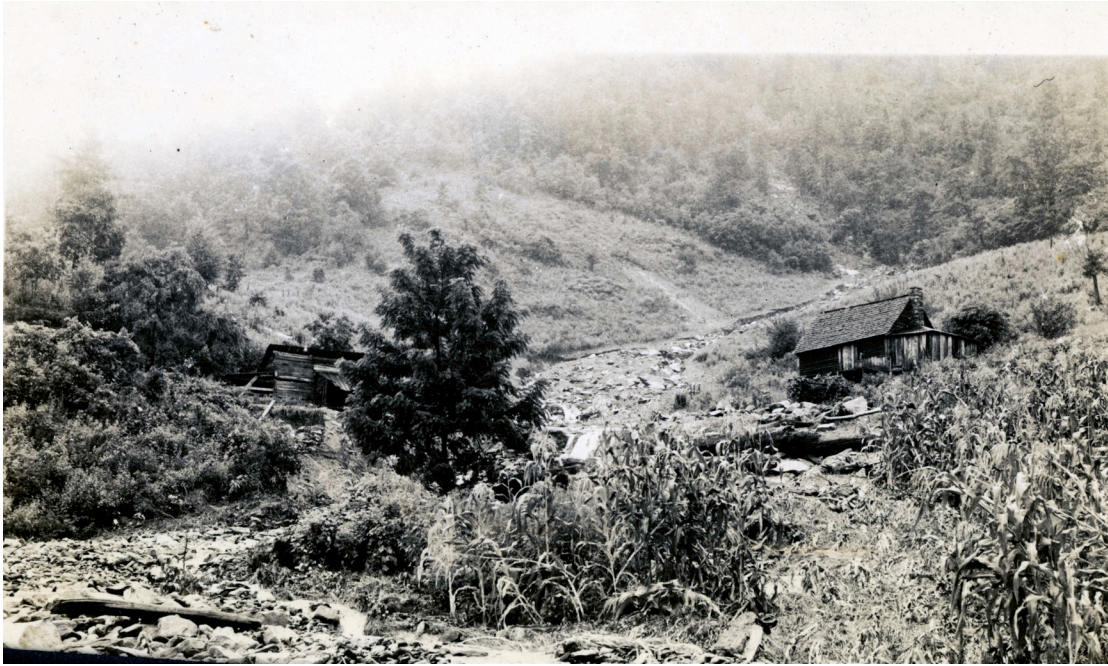
Figure 1: Image of a debris flow that occurred in Stony Fork on the night of 13 August 1940. The debris flow originated upslope (top right) and traveled between a barn and a cabin (owners unknown). Notice the side failure into the main debris flow track near the center of the picture. (Source: Paul Weston, “Landslide with House and Barn, August 1940,” Digital Watauga, accessed August 16, 2018, <https://digitalwatauga.org/items/show/6332>.)

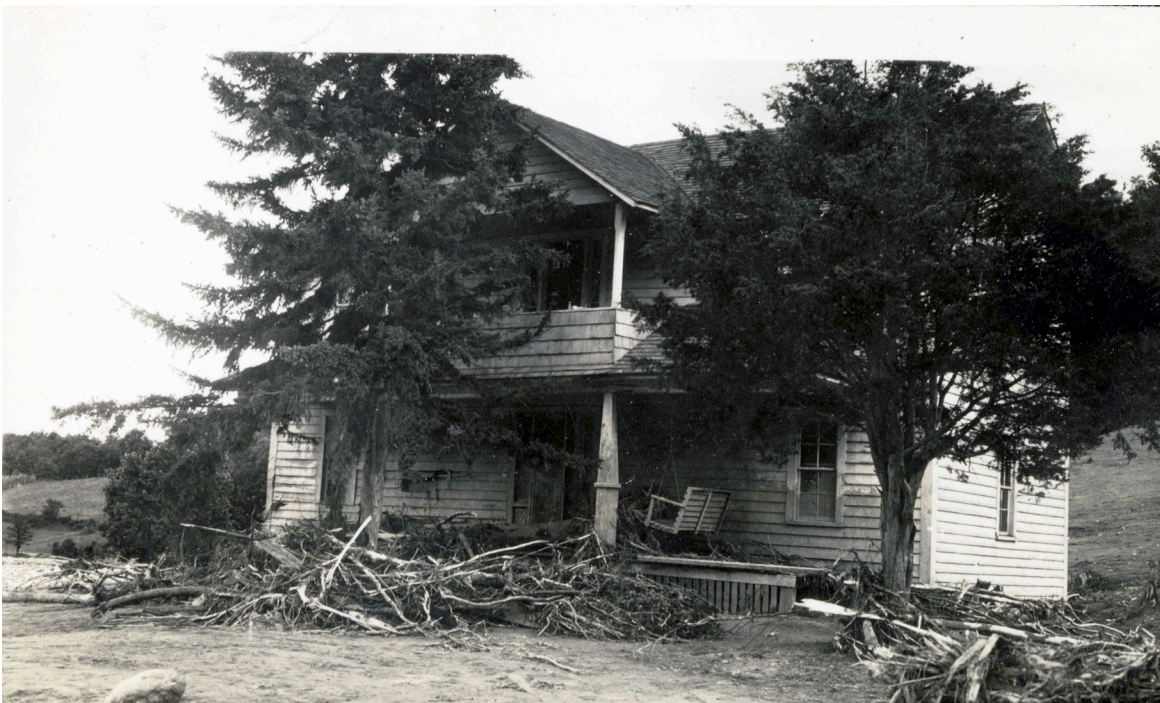
Figure 2: Photograph of the home of Zeb Greene taken soon after the 1940 flood. The cedar tree on the left is probably the tree that saved Worth Greene’s life that night, based on the direction of flow. Also, notice the prominent mud line on the front of the building and porch posts, indicating the height of the debris flow as it surged past the house. (Source: Paul Weston, “Zeb Greene House, Stony Fork, August 1940,” Digital Watauga, accessed August 16, 2018, <https://digitalwatauga.org/items/show/6368>.)

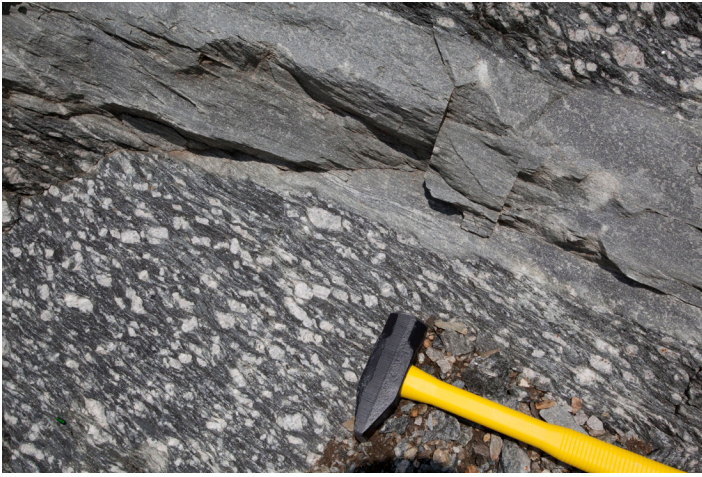
Figure 5. Contact between greenstone and augen gneiss. Note the obliquity between the shape fabric (porphyroclast dimensions) and contact. Primary schistosity within the greenstone is, however, approximately parallel to the augen gneiss foliation. At hammer head there is a ghost fold made from a disarticulated vein.

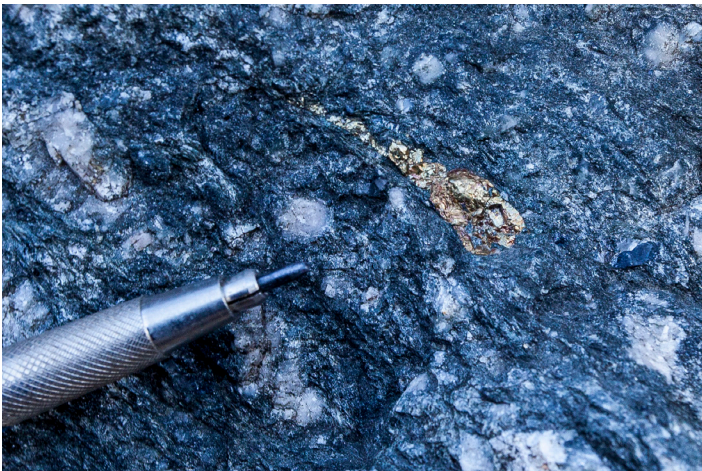
Figure 8. Pyrite or sulfide cluster in augen gneiss. Most pyrite is present as single cubes or clots of a few, but rarely sulfides appear with quartz or calcite tails or as here with a long pyrite tail.

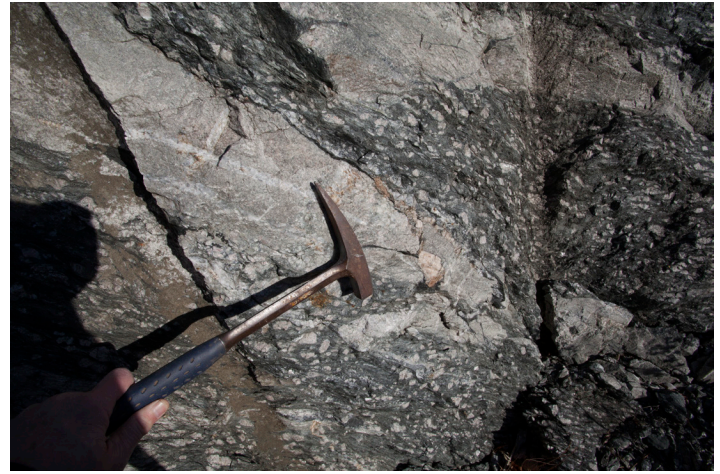
Figure 9. Coarse calcite/dolomite in mixed quartz/carbonate vein. Host rock is mylonitic augen gneiss. The light colored vein beneath hammer head has multiple internal veins that terminate at boundary with matrix. Pink carbonate crystals to right of hammer head. Vein segment beneath hammer and the segment at the top of the image appear to have been continuous at one time, perhaps as joined limbs of an isoclinal fold now broken.

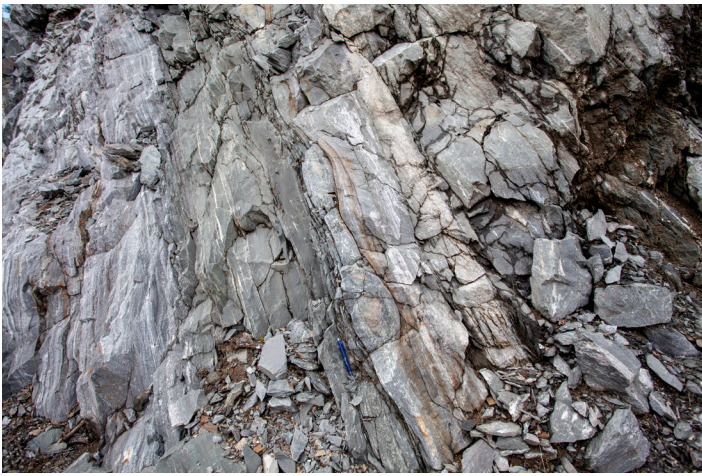
Figure 10. Layered sequence in Wilson Creek Gneiss near Linville metadiabase dike. From left: strongly laminated and layered biotite gneiss generally not showing intense folding seen elsewhere in Wilson Creek Gneiss in this section; non-layered green chlorite-epidote(?) gneiss with calcite or quartz-calcite veins parallel to layering; boudinaged carbonate and/or calc-silicate layer at pencil; massive gray-green weakly layered gneiss. These rocks have not yet been analyzed in detail. The green layer does not have all of the characteristics of greenschists in the north part of the section. It does, however, appear similar to greenschist facies metasedimentary rocks in the Grandfather Mountain Formation to the north.

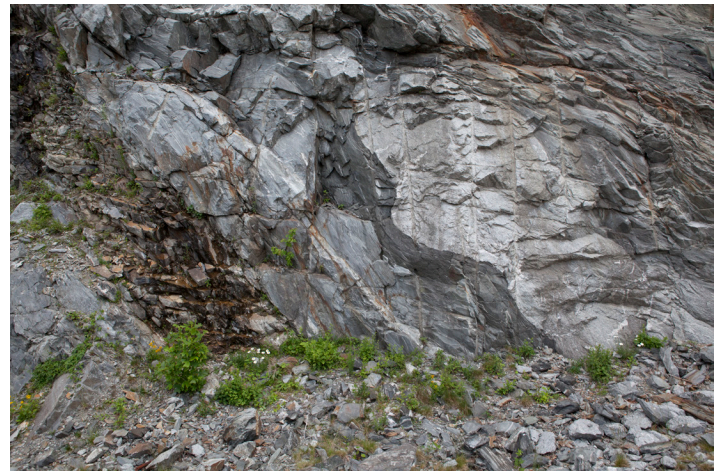
Figure 11. Linville metadiabase(?) at contact between Blowing Rock Gneiss (several meters to the left) and layered phase of Wilson Creek Gneiss. The dike is the dark brown, blocky weathering unit on the left. Below and above the dike is strongly foliated felsic gneiss with concordant leucocratic veins. The overlying dark green layer is a greenschist. Light colored, bulbous layer above greenschist is an orthogneiss(?) in Wilson Creek Gneiss.

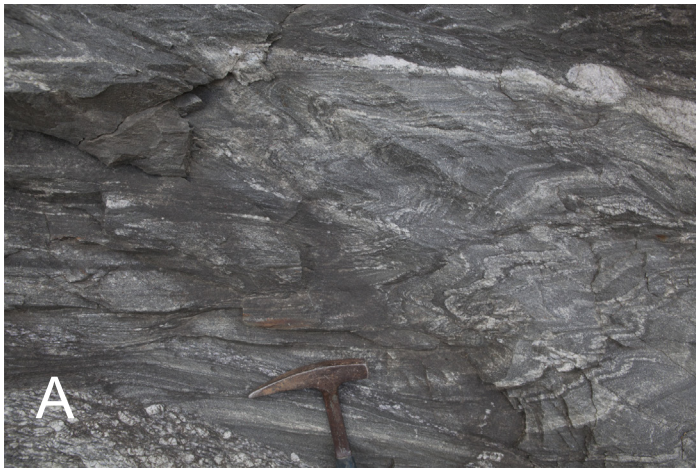
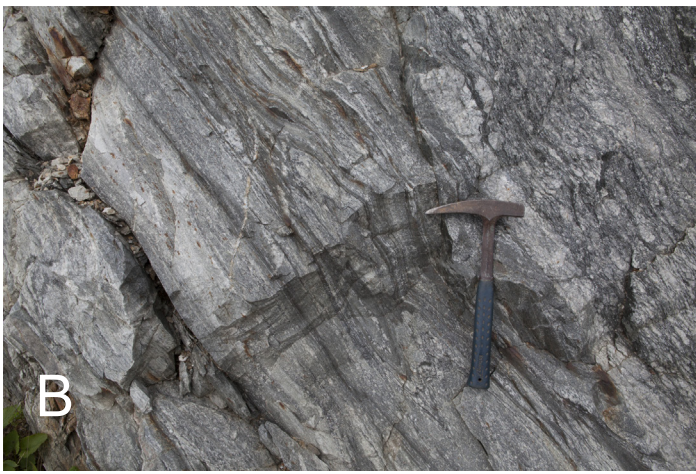
Bryant and Reed (1970) described Linville Metadiabase as mafic rocks (diabase or diorite) metamorphosed to greenschist facies. The Bailey Camp dike

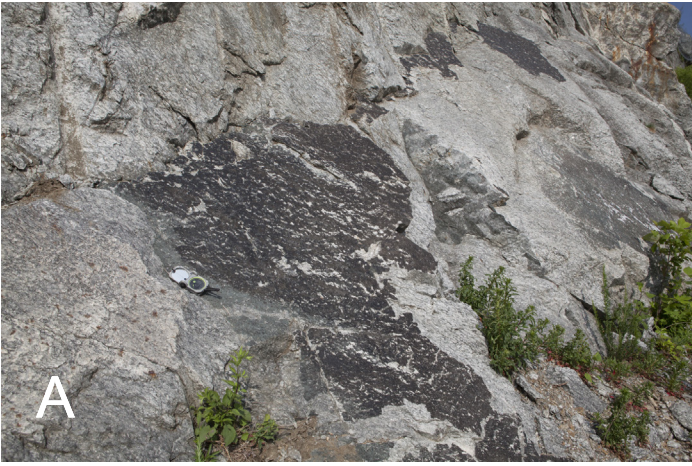
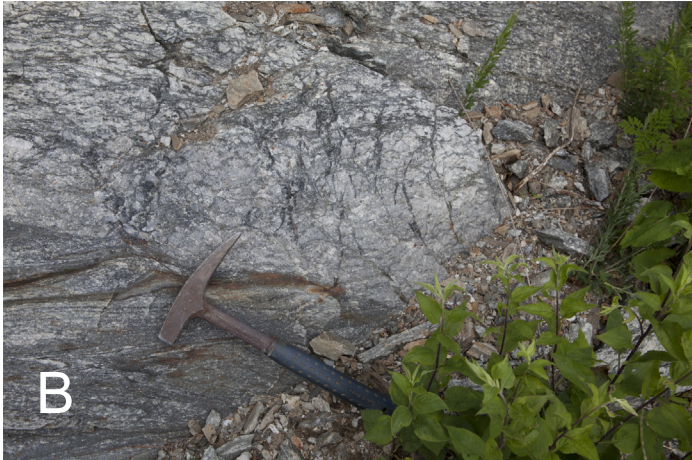
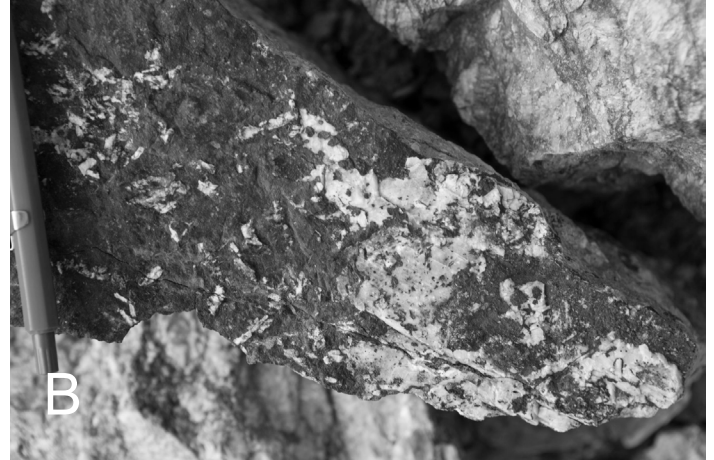
Figure 13. Late, discrete moderately dipping faults and associated structures. These structures are in the Wilson Creek Gneiss part of the Bailey Camp section. A – Planar slip surfaces decorated with chlorite and calcite. These surfaces, interpreted as faults, dip southwest about 45°. Striations and steps on some surfaces indicate oblique thrusting toward southeast. Slickenlines are mainly displayed by chlorite films. Striations in some patches of calcite may have been created during excavation and construction of the road cut. B – Nearly vertical networks of chlorite-filled fractures and microfaults in granite gneiss in close proximity to faults in A. Some of these may be conjugate fractures as a couple were measured with dip vectors of 89°, 140° and 88°, 315°. Slip is minimal but where visible is north side down.

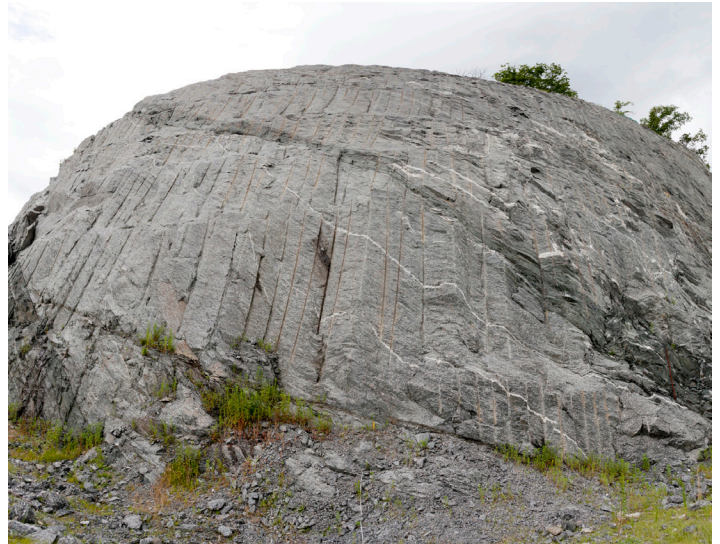
Figure 2. Northern end of main Bailey Camp section. Dark layers are metadiabase dikes. Main rock mass is Blowing Rock augen gneiss. The dike’s compositional boundaries truncate schistosity in gneiss at a low angle. These dikes are thought to be closely folded in the section.

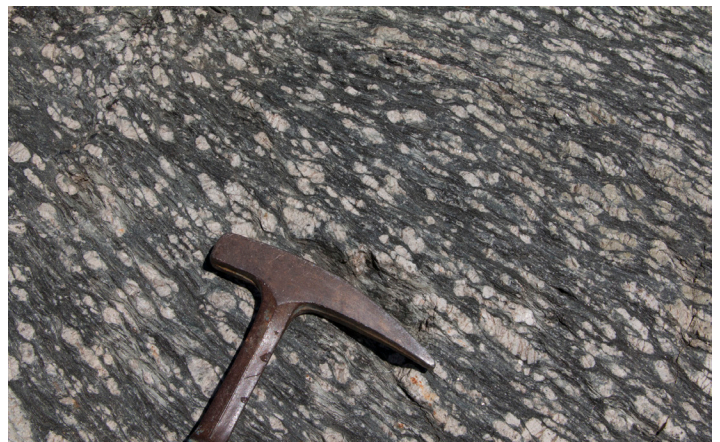
Figure 3. Blowing Rock augen gneiss in Bailey Camp section. This is a moderately deformed part of the section and is an exposure of the VPP viewed toward East. Note that most porphyroclasts are dominoes with sinistral shear sense. (Between cleavage fragments the shear sense is antithetic.) Many sinistral sigma porphyroclasts are visible. The dark matrix is quartz-chlorite-sericite-biotite.

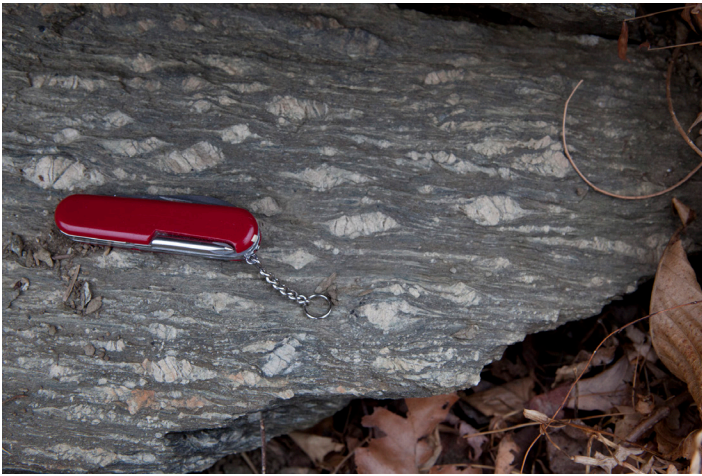
Figure 4. Sheared domino porphyroclasts in mylonitic augen gneiss. This outcrop is in a shear zone between the main Bailey Camp section exposure and a smaller northern section. It is one of the areas where shear sense is equivocal. Domino morphology suggests sinistral shear but tails on some porphyroclasts if they are interpreted as sigma porphyroclasts is dextral. The view is looking down the VPP normal direction.

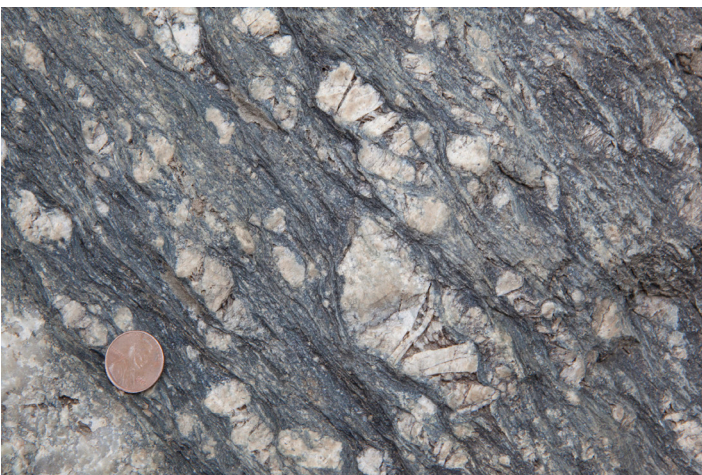
Figure 5. Internally deformed domino porphyroclasts in mylonitic ("cataclastic") section of Blowing Rock gneiss. Note the waviness of the schistosity as less viscous matrix was displaced by rigid clasts during flow. Some porphyroclasts are also crenulated and have split along wedge fractures filled in by quartz. It is possible that some of these structures are the results of interactions between rigid clasts. View is looking down the VPP normal.

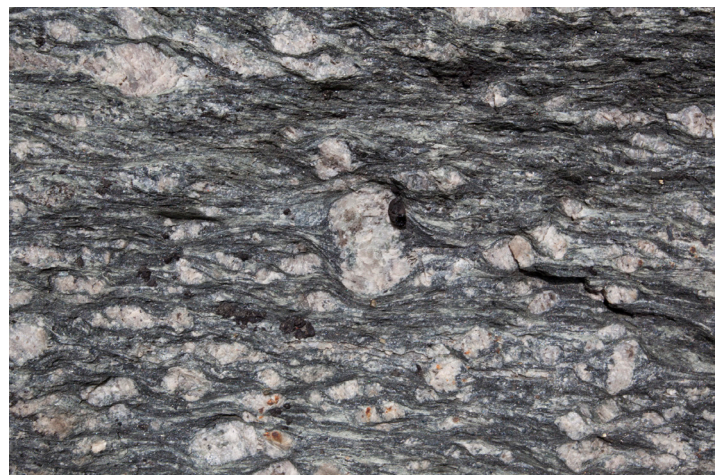
Figure 7. Possible back-rotated porphyroclast. It is very uncommon to find the long axes of porphyroclasts at such a high angle to the flow plane/schistosity. In some shear zones, these orientations are supportive of the pure shear component of deformation. Here it is also possible that this grain is a remnant of a ghost fold (see text) or spawned from a larger porphyroclast, though none is visible in the image. View is looking down the VPP normal.

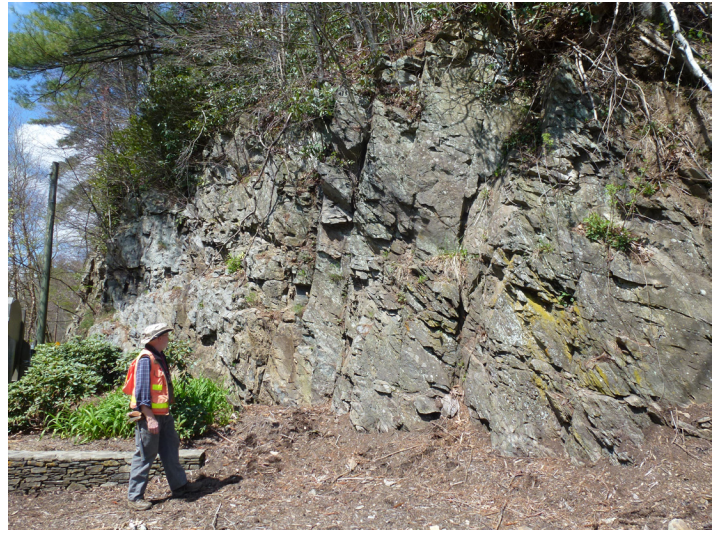
Figure 3: Photo looking WNW along strike of the Boone fault, where high angle faults visibly cut metamorphic foliation associated with the Linville Falls fault (station 003 in Figure 4). These high angle faults show south-side-up motion consistent with uplift of the Grandfather Mountain window along the Boone fault.

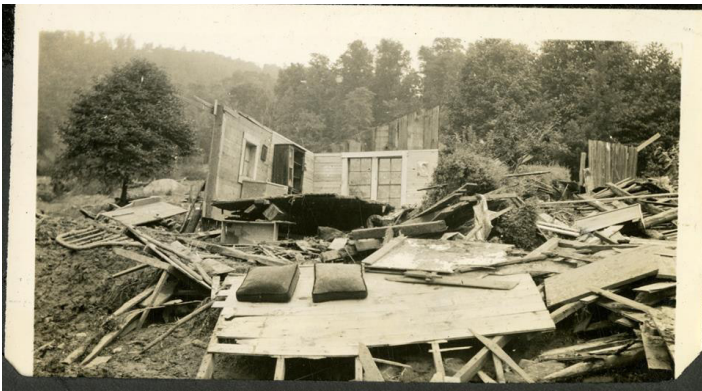
Figure 8: The remains of the Millard Greene residence, destroyed by a debris flow originating upslope. (Source: Paul Weston, “Interior of Millard Greene House #3, August 1940,” Digital Watauga, accessed August 16, 2018, <https://digitalwatauga.org/items/show/6363>).

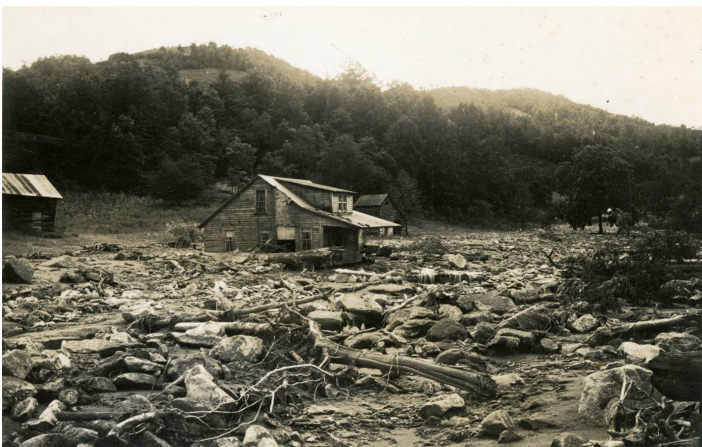
Figure 9: The wreckage of the home owned by Bessie Greene within bouldery debris flow material. Notice the large tree, a sugar maple, at the side of the house. This tree brought the home to an abrupt stop and prevented it from continuing downstream. The Greene family repaired the home and it still stands today. (Source: Paul Weston, “Bessie Greene House, Moved Off Foundation by Flood, August 1940, #2,” Digital Watauga, accessed August 16, 2018, <https://digitalwatauga.org/items/show/6313>).

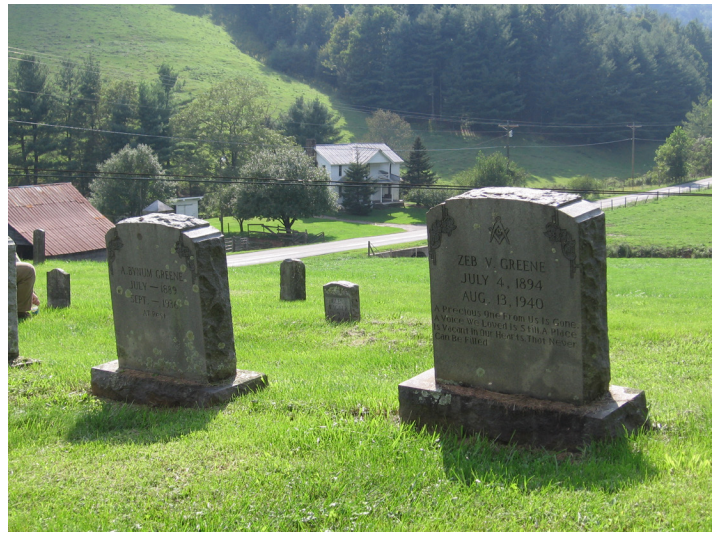
Figure 10: Photograph of the tombstone of Zeb Greene, killed on the night of August 13, 1940 when he was swept from the front porch of his house by landslide and flood debris. The white house in the center of the photograph is the Zeb Greene residence. The home remains in the Greene family through descendants of Zeb’s brother Elster, who moved into the home after the 1940 flood. Photo by Anne Witt.

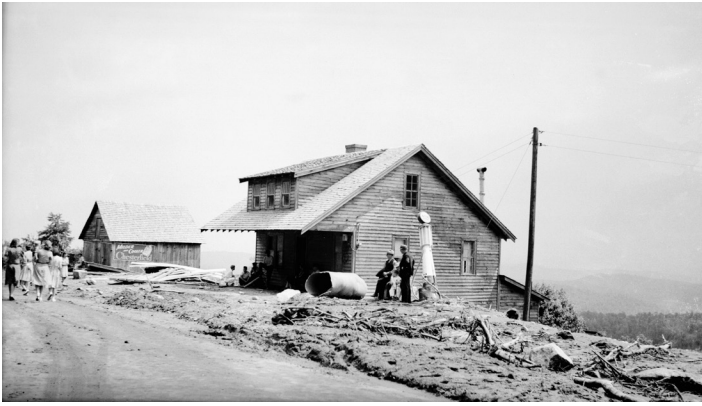
Figure 12: A 1940 photograph of Otus Watson’s house after a 1940 debris flow, originating from Thompkin’s Knob, destroyed his filling station. Notice the gas pump near the center of the photograph. Photographer unknown. Courtesy of the Ashe County Public Library, NC Digital Collections (Available online: <https://library.digitalnc.org/cdm/ref/collection/ncimages/id/3428>)

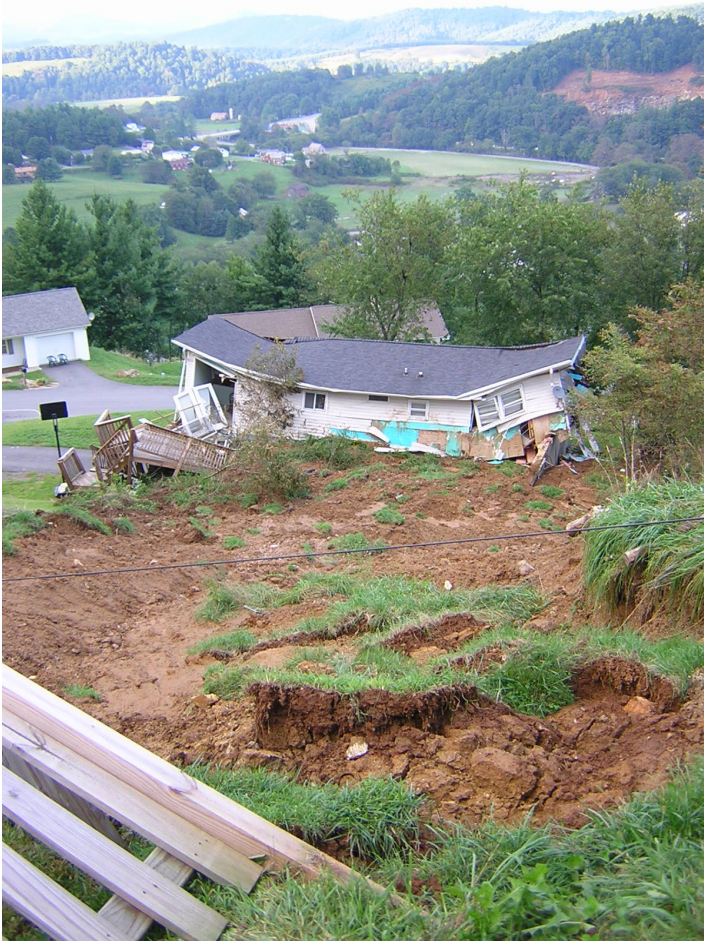
Figure 5: Home in the White Laurel community destroyed by an embankment (fill) failure that mobilized into a debris flow on September 8, 2004 during rainfall from the remnants of Hurricane Frances. 2004/09/08 NCGS photo.

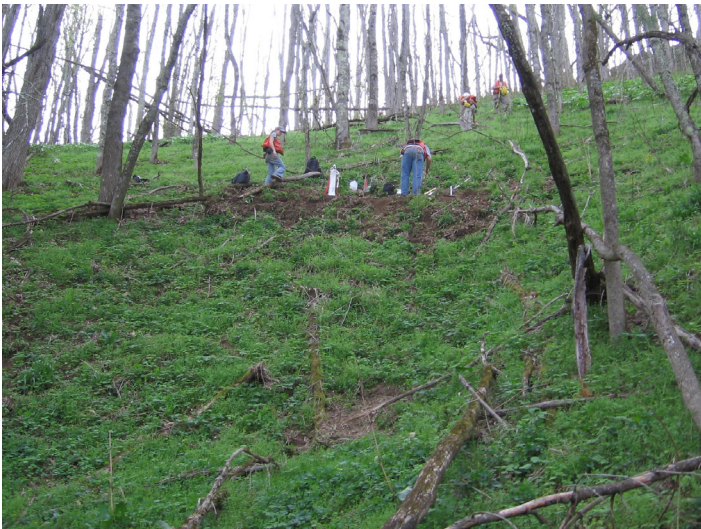
Figure 14: NCGS field crew investigating an August 13-14, 1940 debris flow initiation at detailed study site ID 4208 (location on Fig. 3) within a colluvial hollow. Concave topography in the fore- and middle-ground of the photo is the debris flow source area. 2007/05/01 NCGS photo.
